FLOOD RESISTANT HOUSING

LOW-COST DISASTER-RESISTANT HOUSING IN BANGLADESH

technical brief

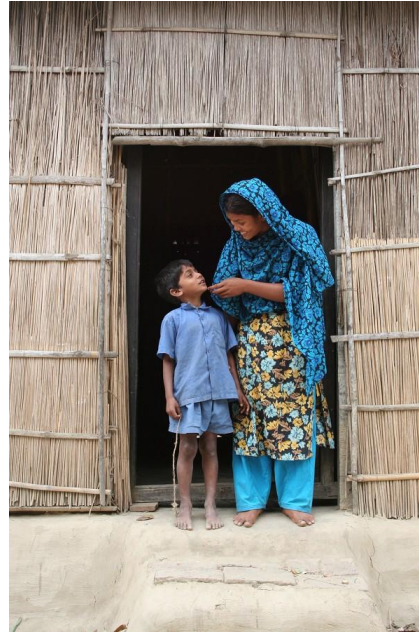
Figure 1: Hosne Ara (14 yrs) and Faruq Hussein (10 yrs) live with their parents in Wazuddin Fakirer Dangi, The house is built on a raised plinth made from sand, clay and cement. Photo: Practical Action Bangladesh.

The house is built on a raised plinth made from sand, clay and cement (meaning it is less likely to be washed away in floods), and made using concrete pillars and treated bamboo poles. Strong and high enough to last through repeated floods, unlike the traditional earthen floors that simply wash away.

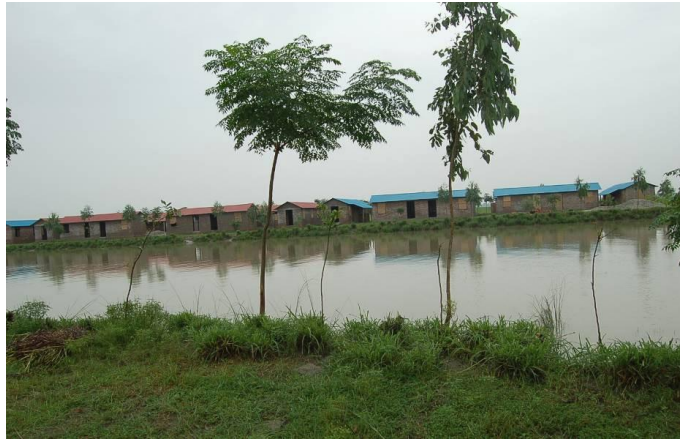
Figure 6 : A completed cluster village with pond for community fish culture. Photo: Practical Action Bangladesh.

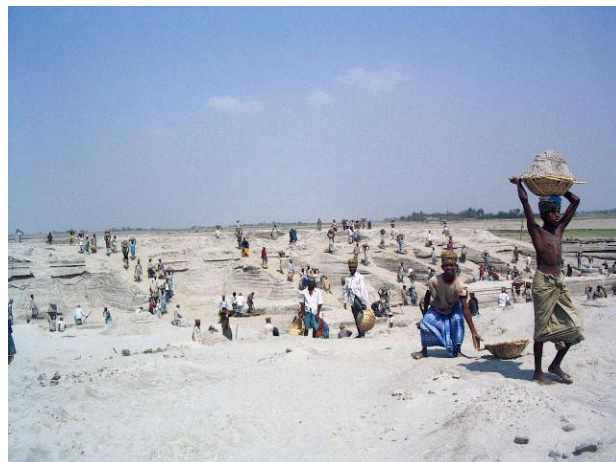
Figure 8: The whole community work together to make a large raised platform for the cluster village.
Photo: Practical Action Bangladesh.

The cluster village is made in a collaborative way; people excavate soil and sand from one area to build an earth platform. This is done in the dry season December to April. The hole where the soil/sand is excavated from creates a reservoir which is used by the community for various livelihood initiatives such as fish farming, duck rearing, floating gardens etc.
